**CORRELATION OF STRESS-WAVE-EMISSION
CHARACTERISTICS WITH
FRACTURE IN ALUMINUM ALLOYS**

*by C. E. Hartbower, W. G. Reuter,
C. F. Morais, and P. P. Crimmins*

Prepared by
**ADVANCED TECHNOLOGY
AEROJET SOLID PROPULSION COMPANY
Sacramento, Calif.**

NATIONAL AERONAUTICS AND SPACE ADMINISTRATION • WASHINGTON, D. C. • JULY 1972

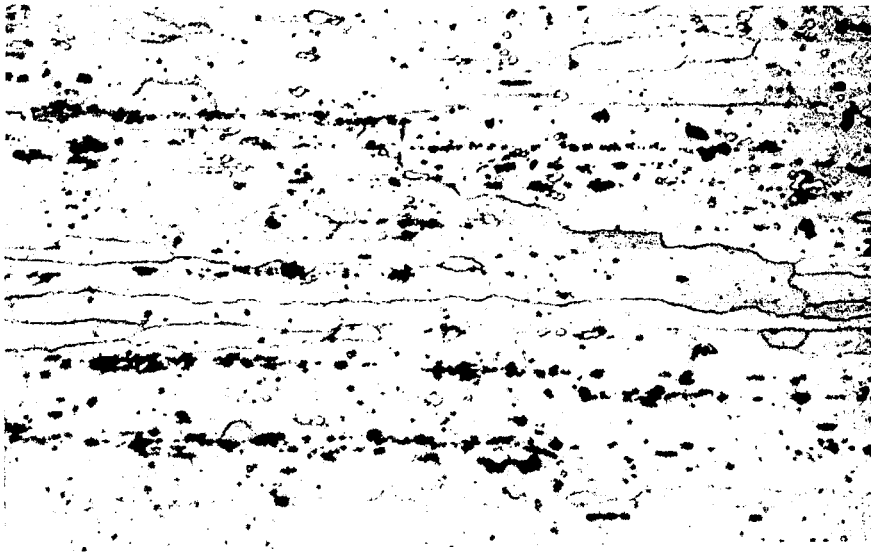
Figure 1. Typical Microstructure of 2014-T651 Aluminum Alloy 0.3-in. Thick Plate Material

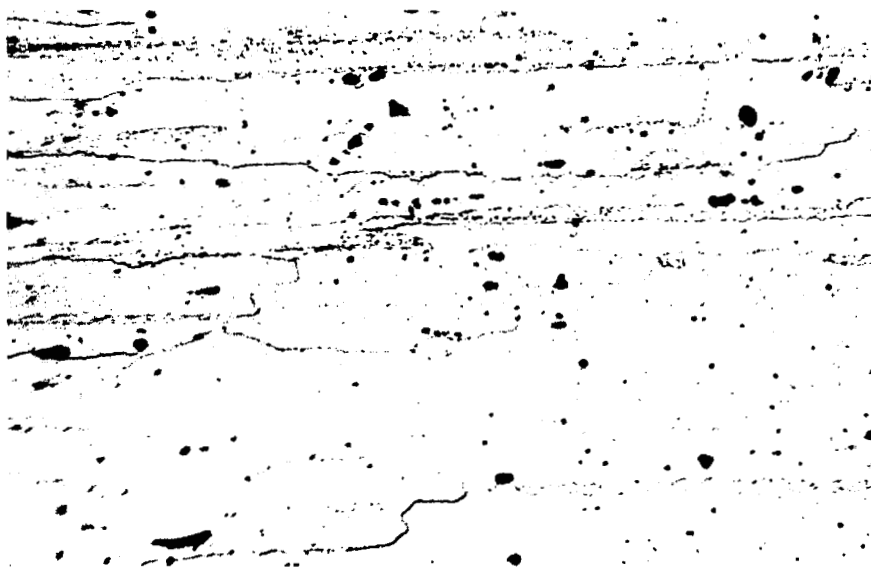
Figure 2. Typical Microstructure of 7075-T73 Aluminum Alloy 0.3-in. Thick Plate

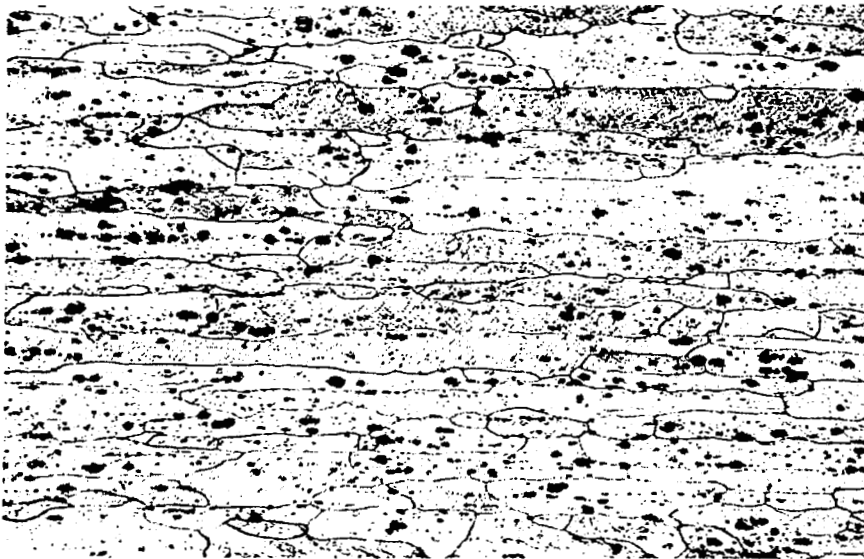
Figure 3. Typical Microstructure of 2219-T87 Aluminum Alloy 0.3-in.-Thick Plate Material.

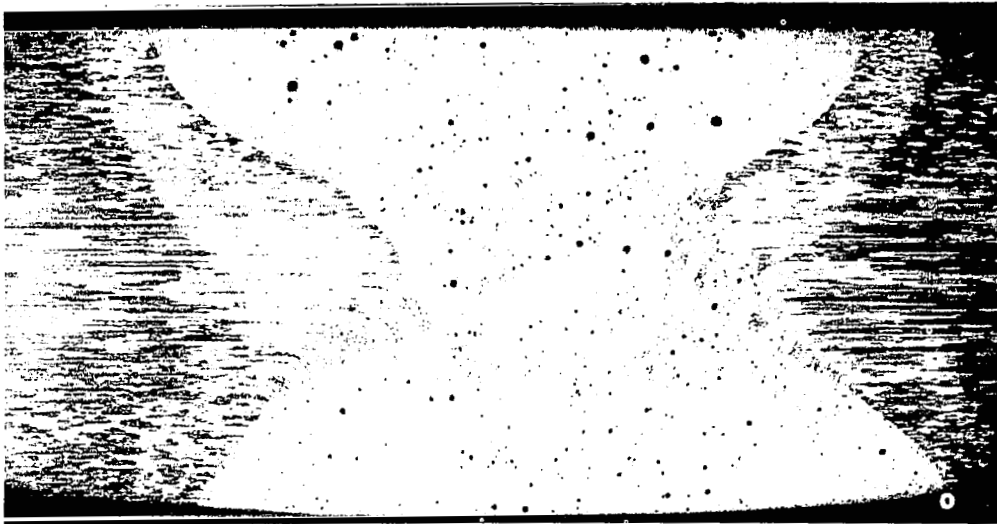
Figure 5. Typical Macrostructure of MIG Weld (4043 Filler Wire)
in 0.3-in. Thick 2014-T651 Aluminum Alloy Plate

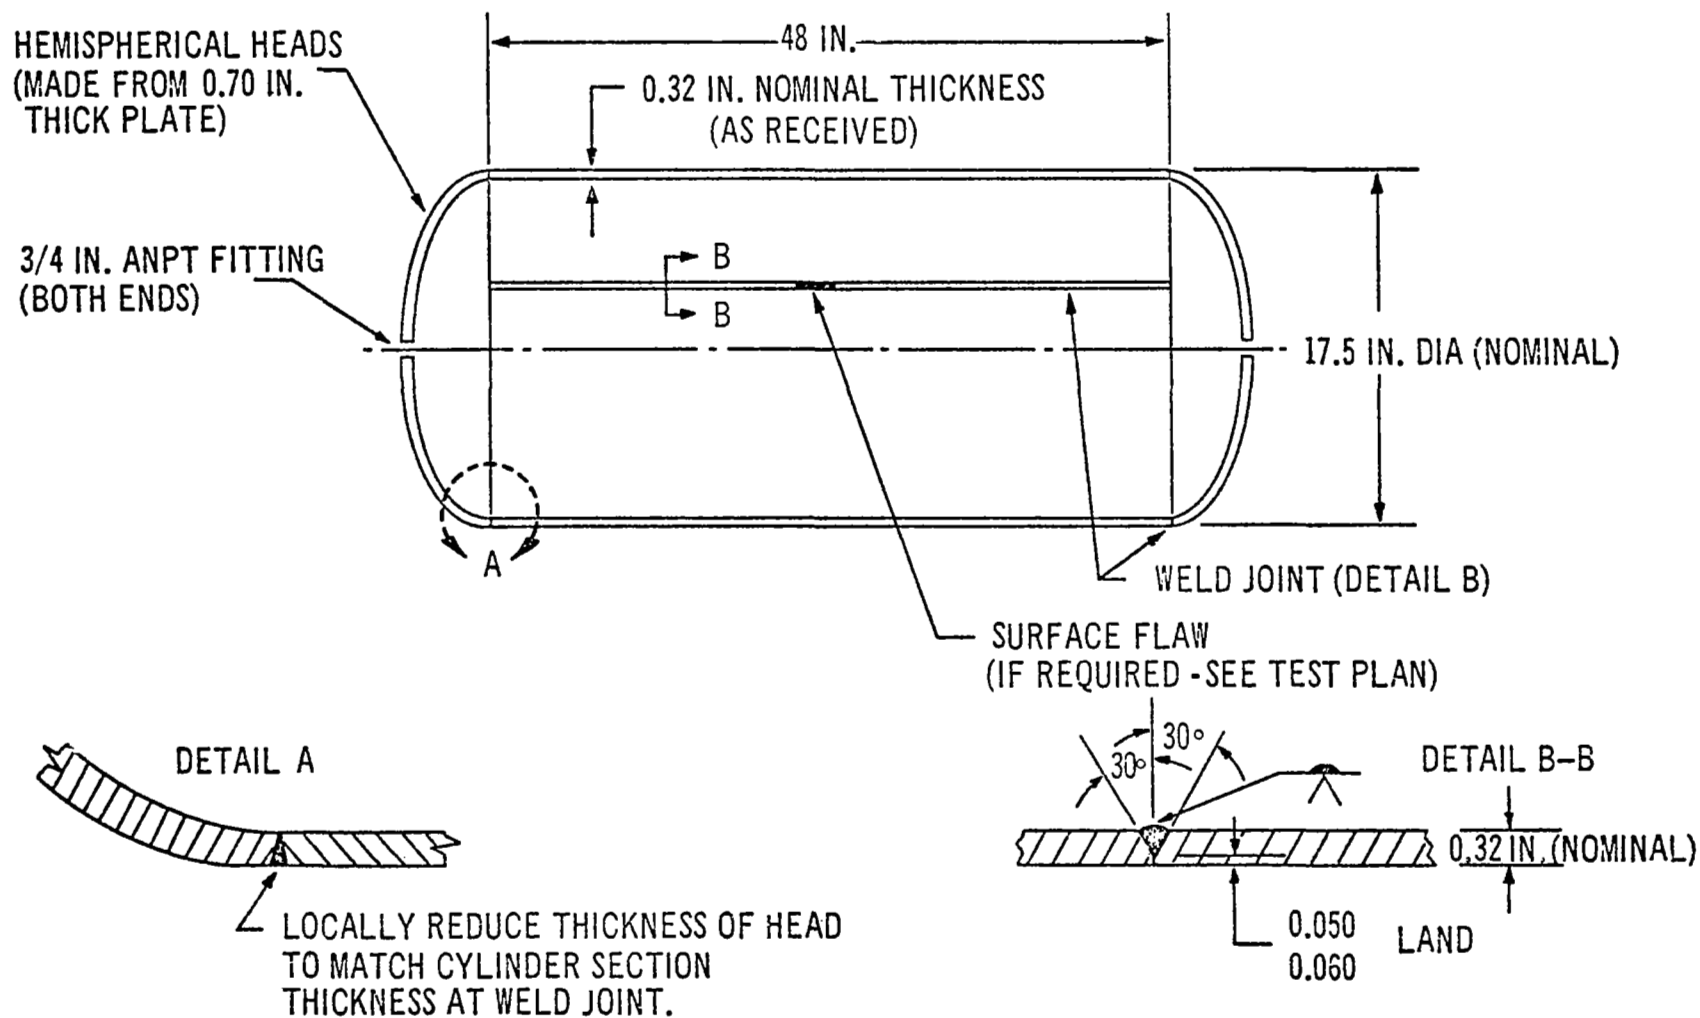
Figure 7. Subscale Pressure Vessel Design

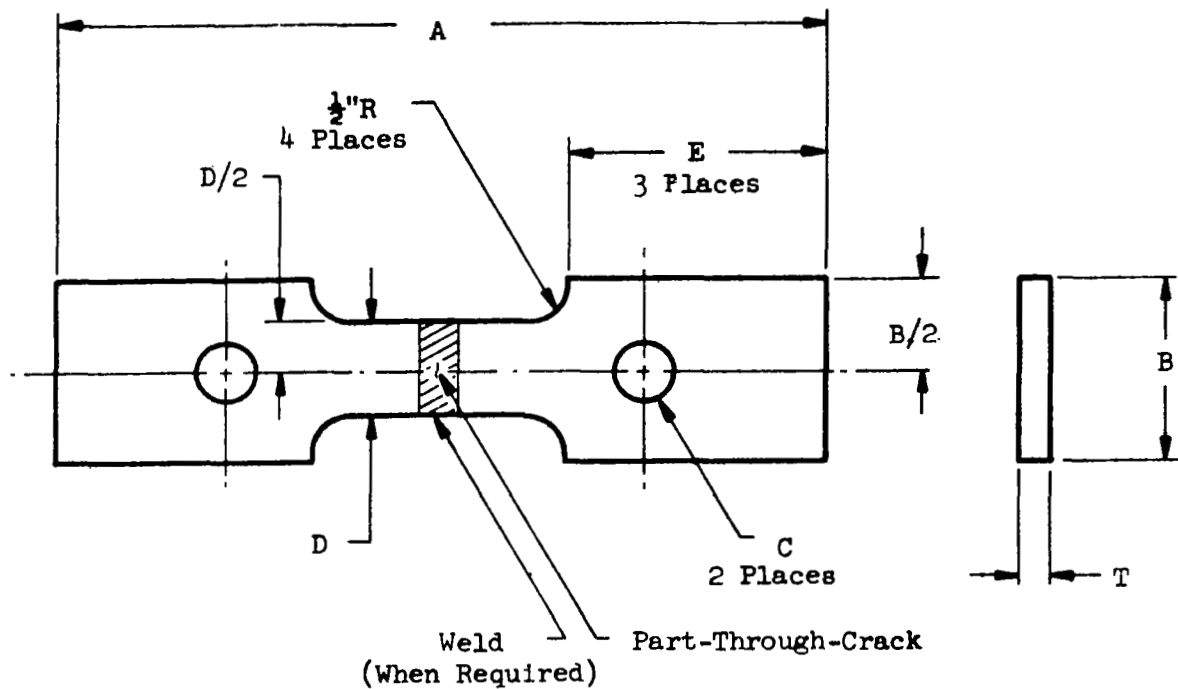
Test Temperature	A	B	C	D	E
Room and -320°F	16.00	4.00	1.25	3.00	5.00
-423°F	11.00	2.50	1.00	1.50	3.50

Figure 8. Part-Through-Crack Tension Specimen and Knife-Edge Attachments to Accommodate the Crack-Opening-Displacement Gage

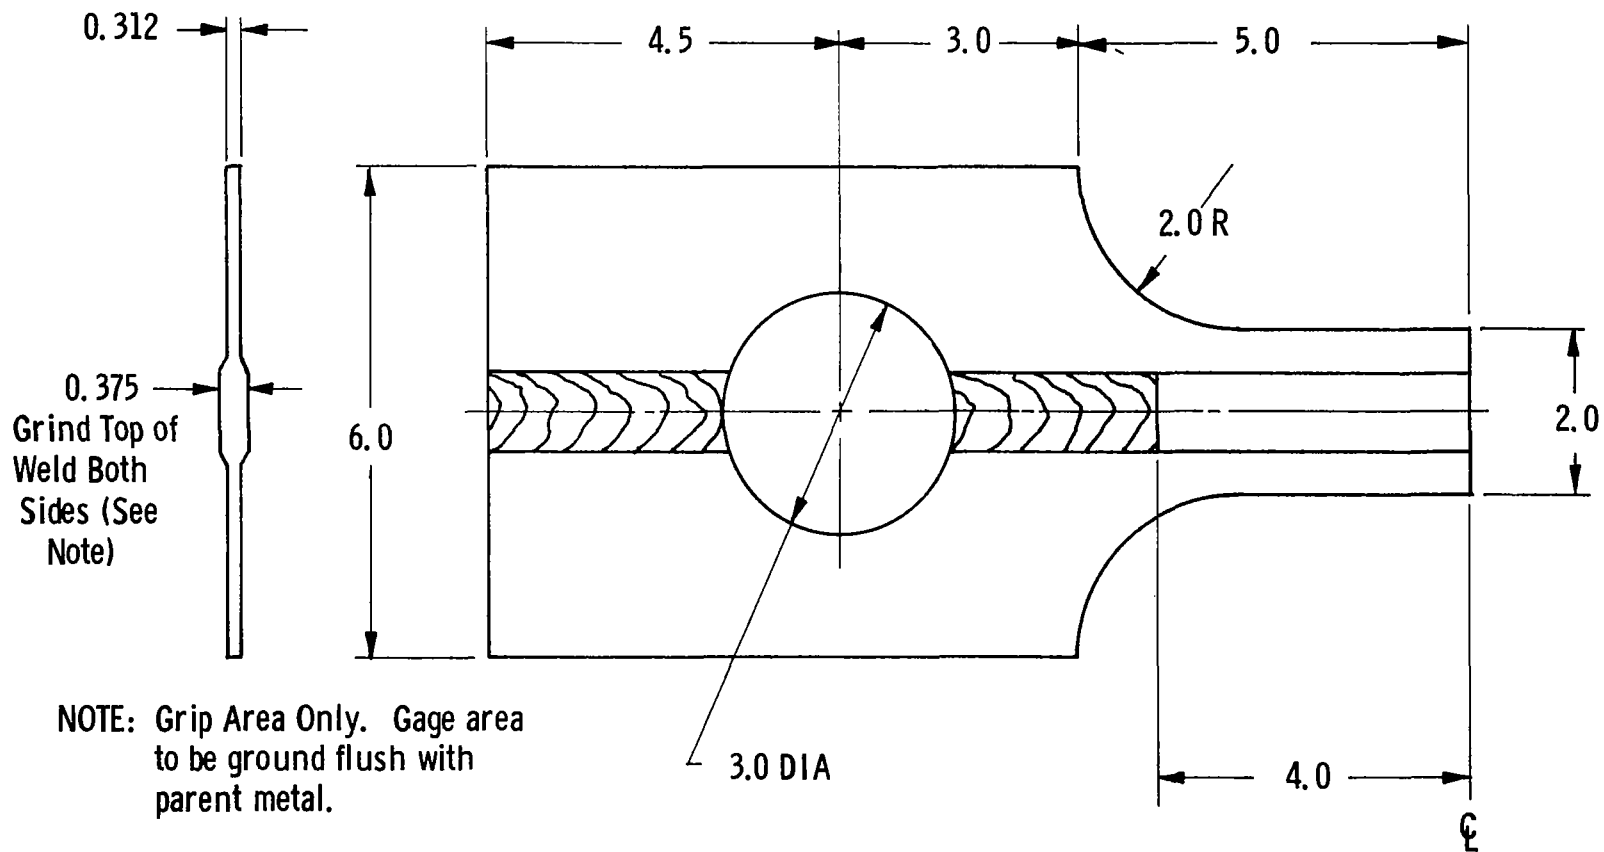
Figure 9. Longitudinally Welded Unflawed and Part-Through-Crack Tension Specimen.
(Room and -320°F Tests)

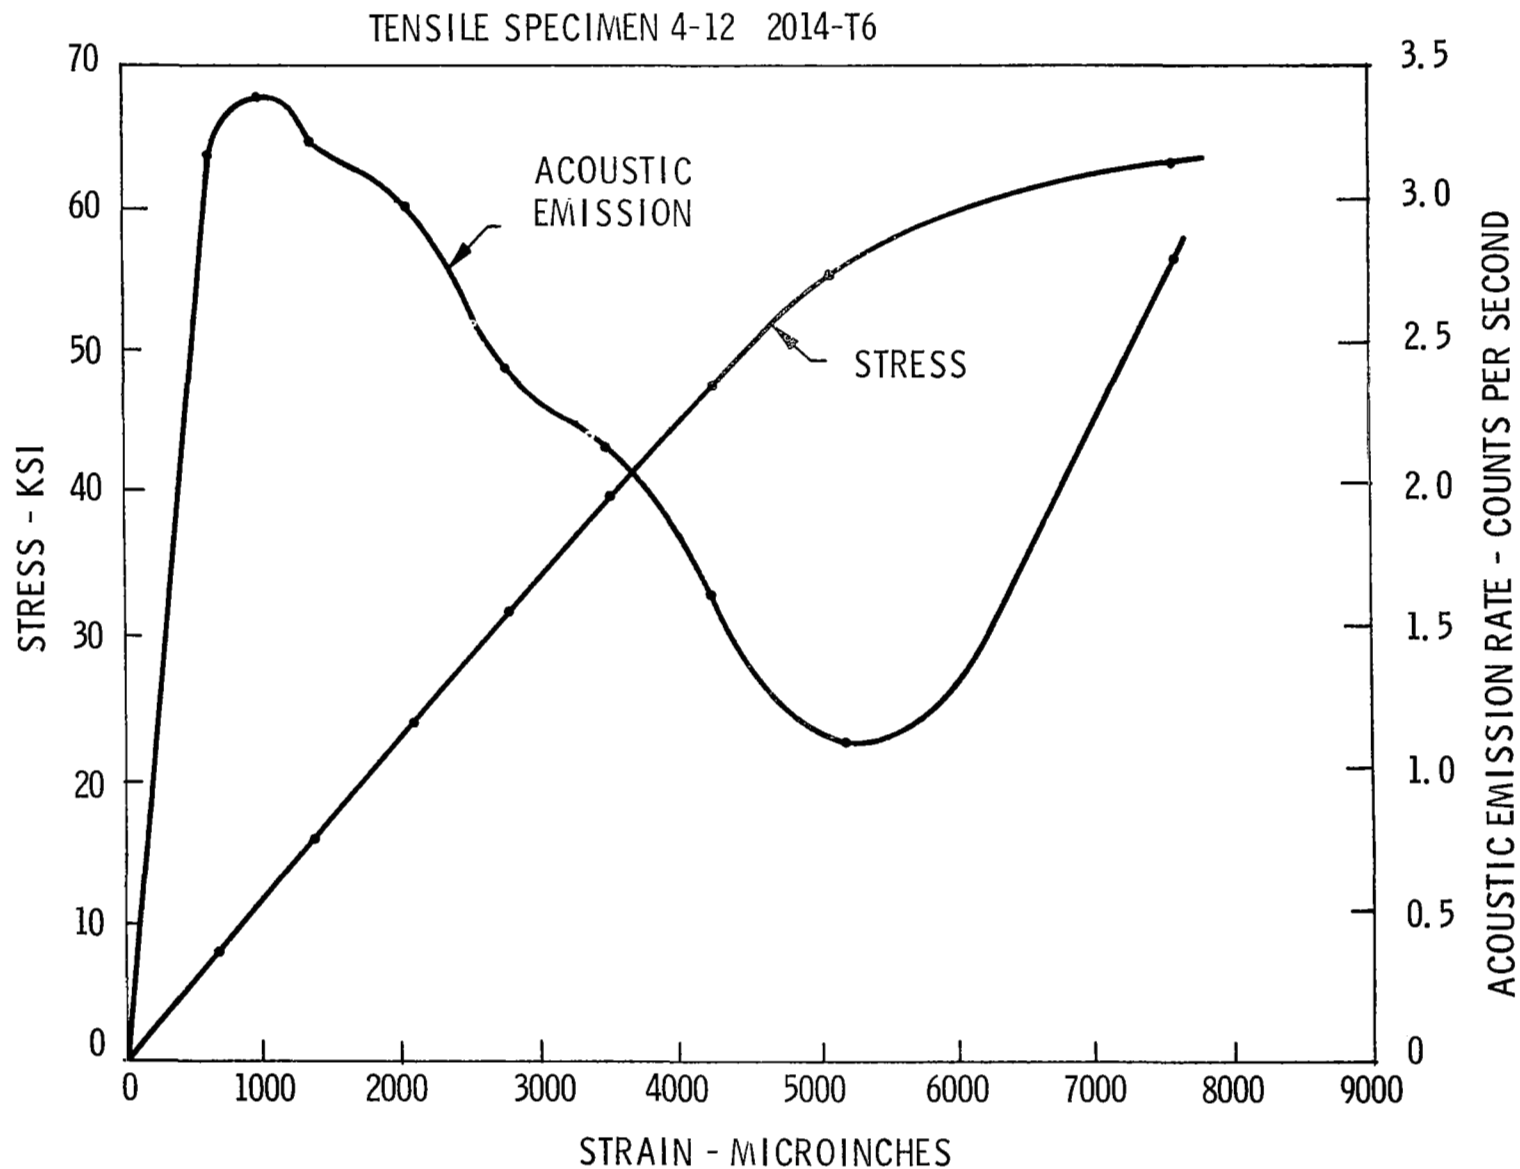
Figure 10. Effect of Pin-Hole Irregularities on Acoustic-Emission Count Rate on Initial Loading.

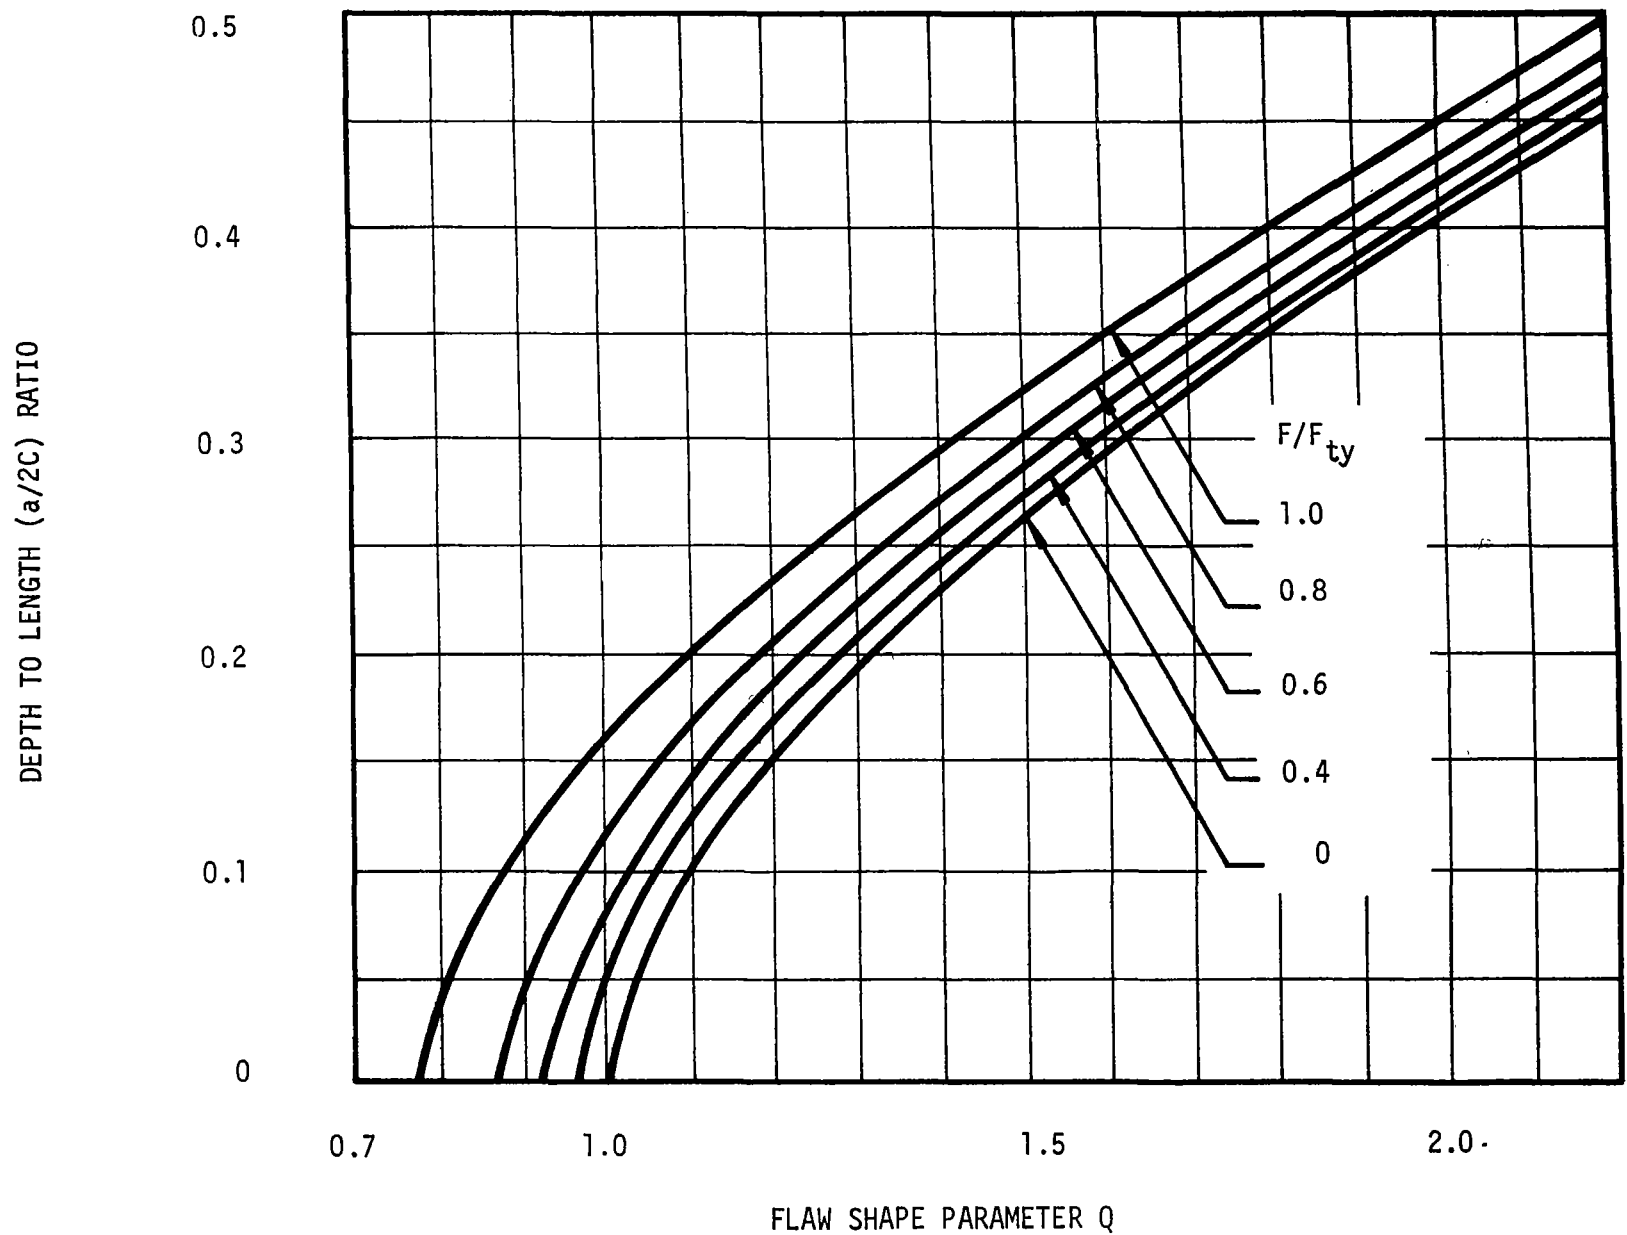
Figure 12. Flaw Shape Parameter, Q , for Surface and Embedded Flaws

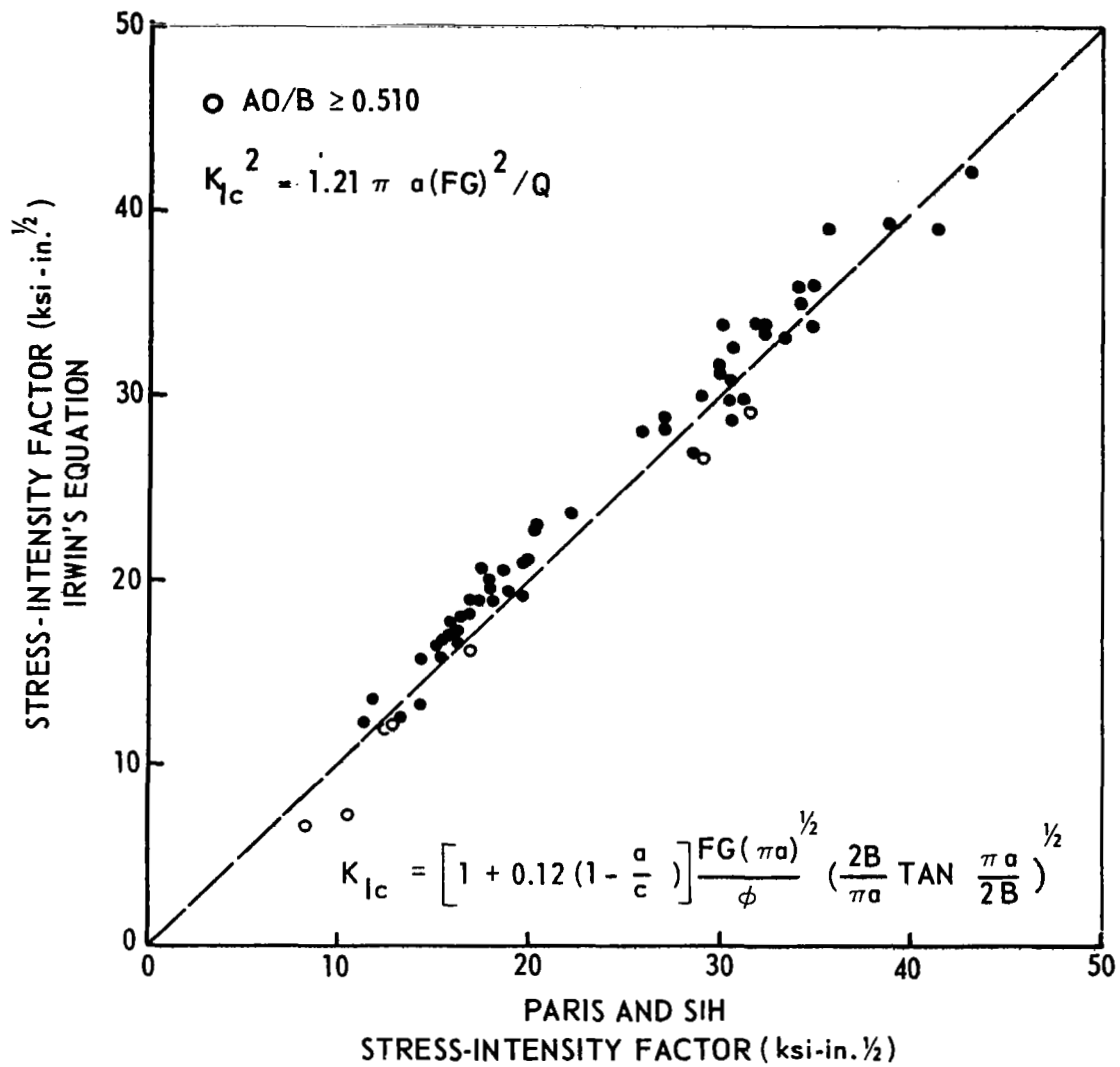
Figure 13. Comparison of the Irwin and Paris and Sih Approximations for Calculating Stress-Intensity Factors for Surface Cracks

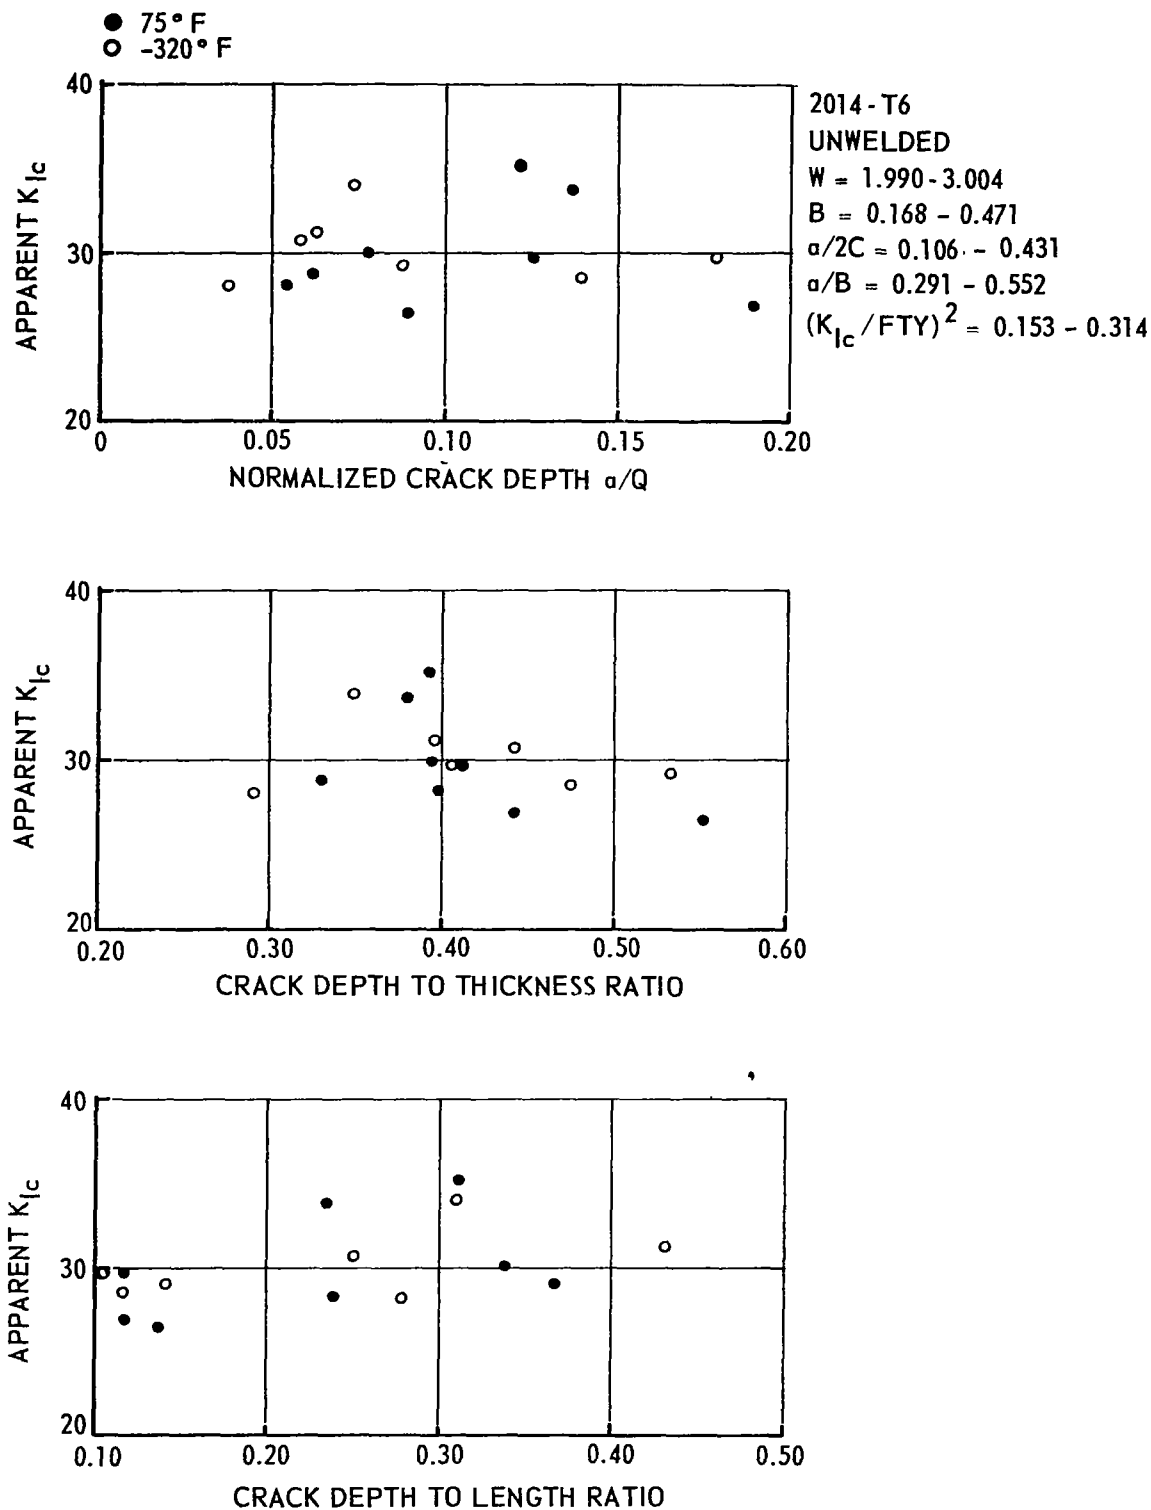
Figure 14. Effect of Crack Depth and Flaw Shape on the K_{Ic} Value

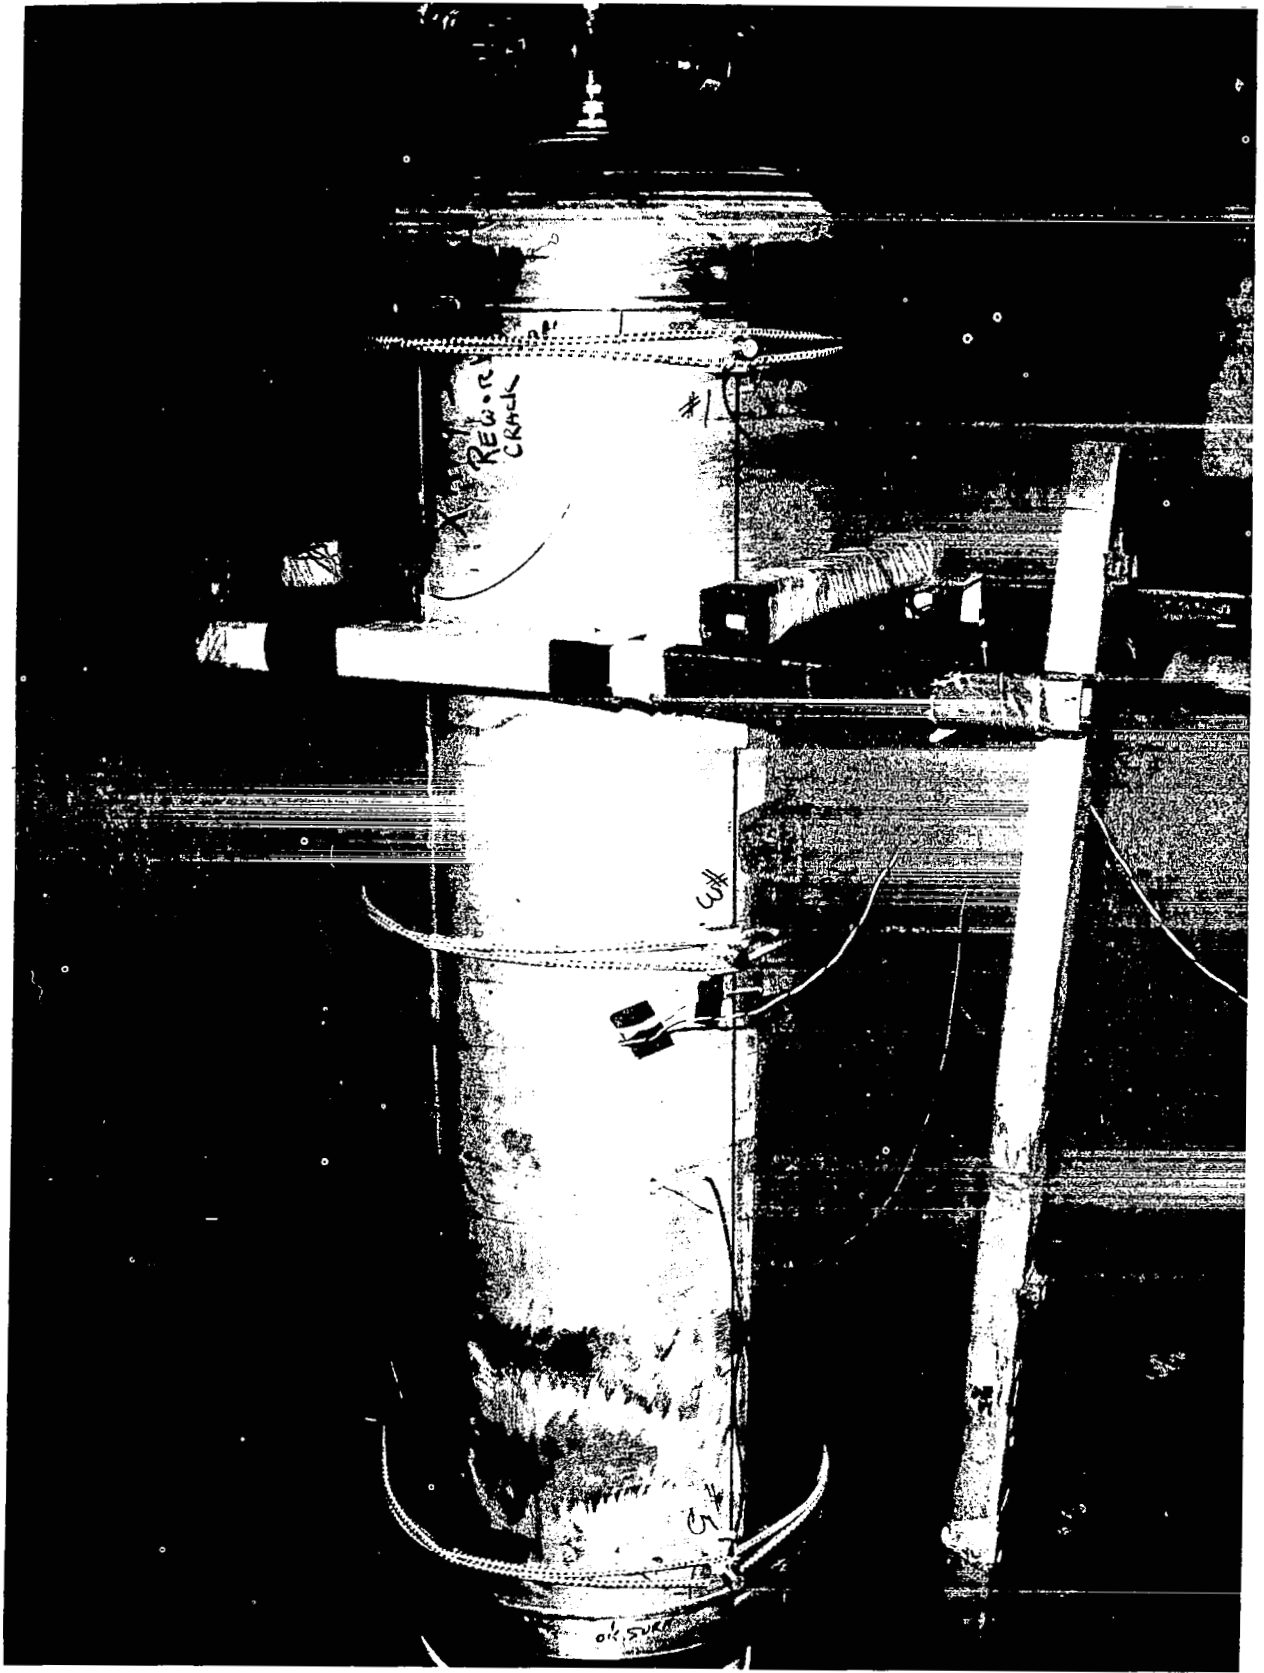
Figure 18. Pressure Vessel Test Set-up

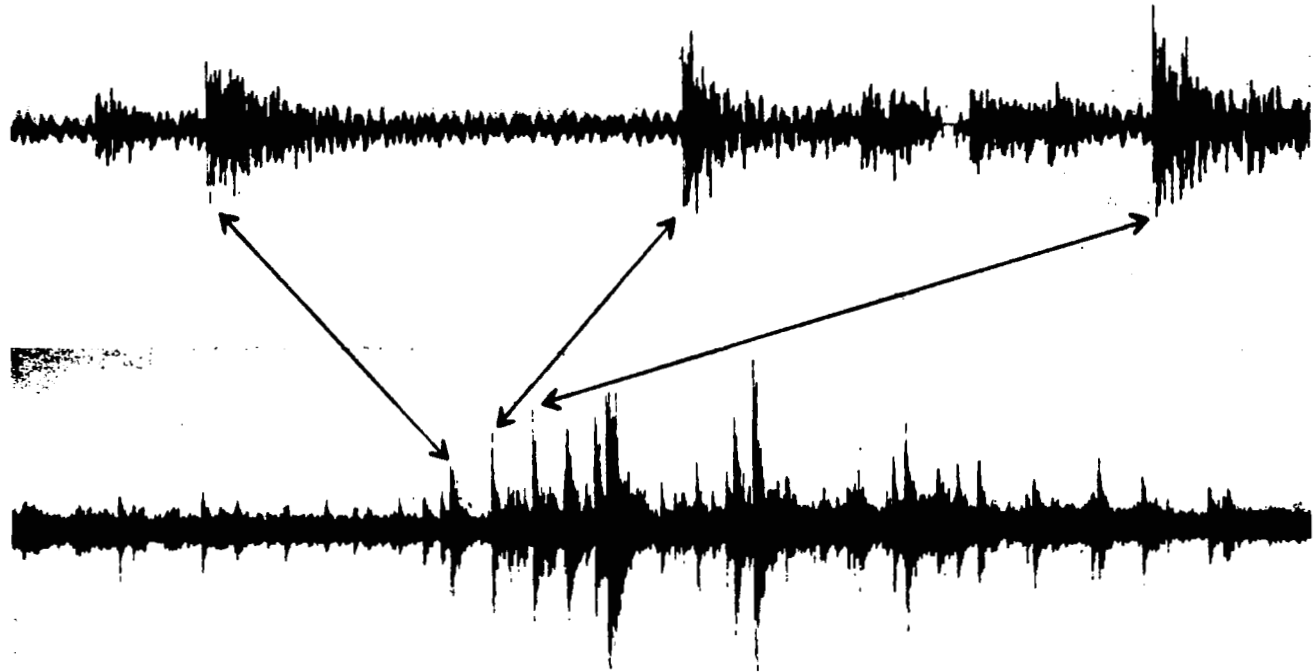
NOTE: These photos illustrate typical sensor resonant ring down decay after receipt of burst type stress wave.

Figure 21. Burst Type Stress Wave Emissions

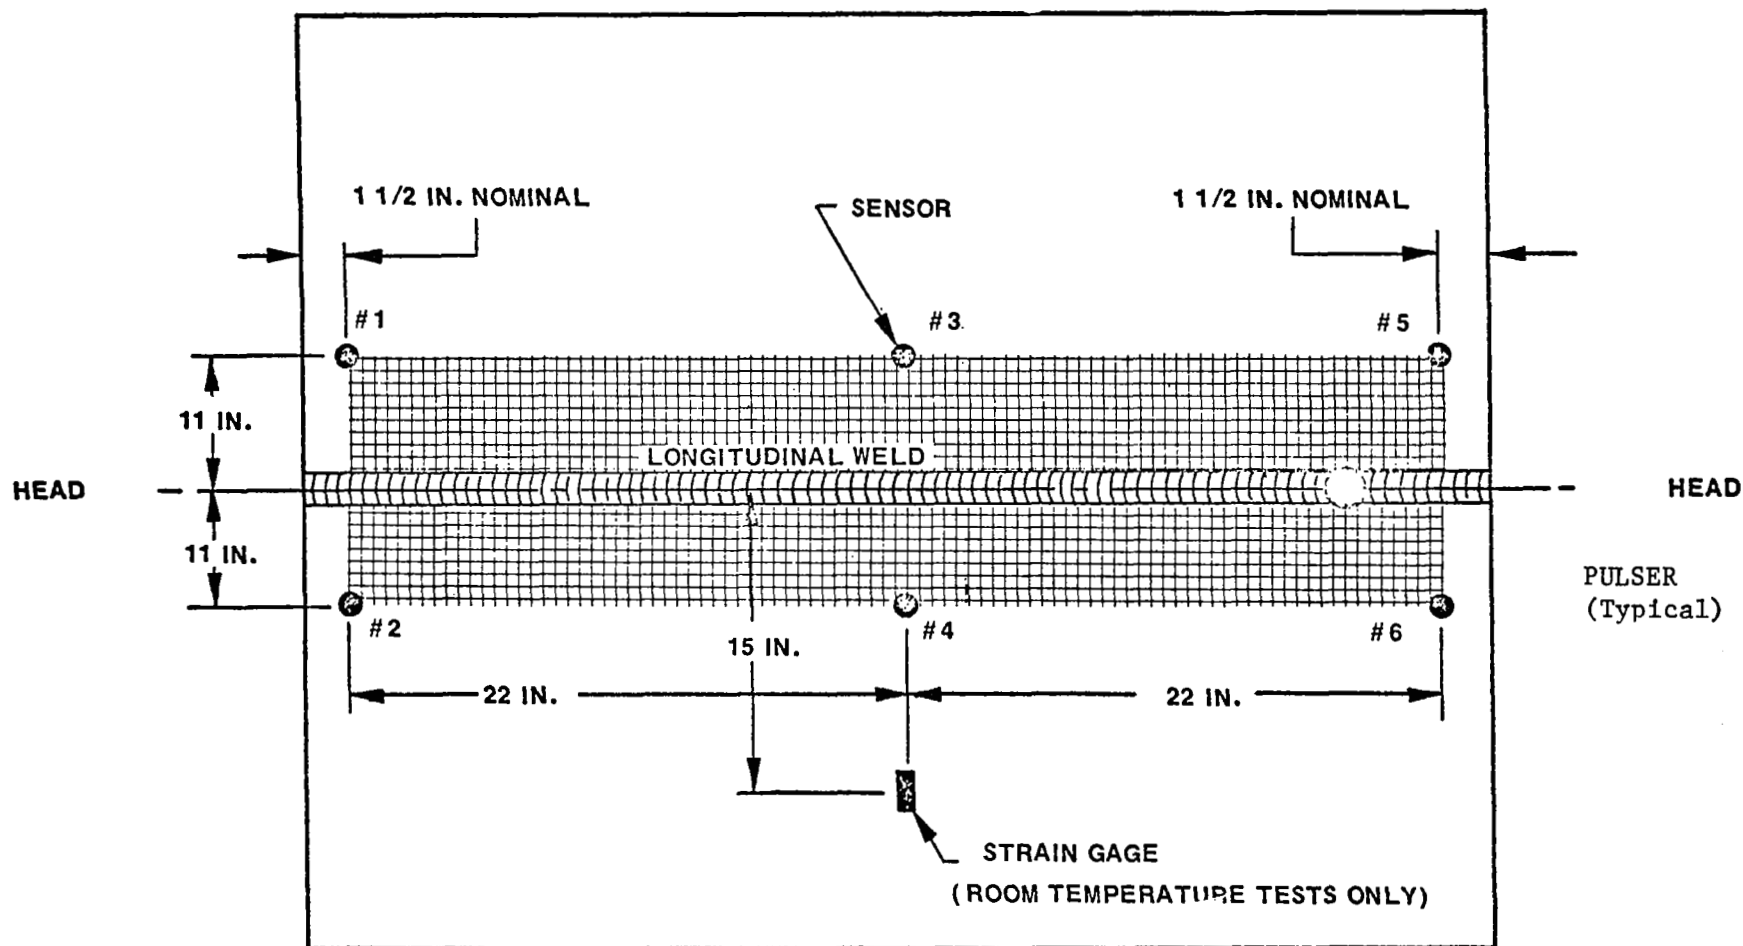
NOTE: 1. CROSSHATCHING INDICATES AREA MONITORED BY SWAT SYSTEM.

2. BECAUSE OF EXCESSIVE SENSOR DAMAGE DURING THE FIRST -320°F TEST, ONLY SENSORS 1 - 4 WERE USED FOR THE 2219 VESSEL TESTED AT -320°F . ALSO FOR THIS TEST SENSORS 1 AND 3 WERE OFFSET FROM THE WELD BY 8 INCHES AND SENSORS 2 AND 4 OFFSET FROM THE WELD BY 14 INCHES.

Figure 22. Location of Stress Wave Emission Monitoring Sensors, Strain Gage and Area Surrounding the Vessel Longitudinal Weld Which was Monitored During Hydrotest.

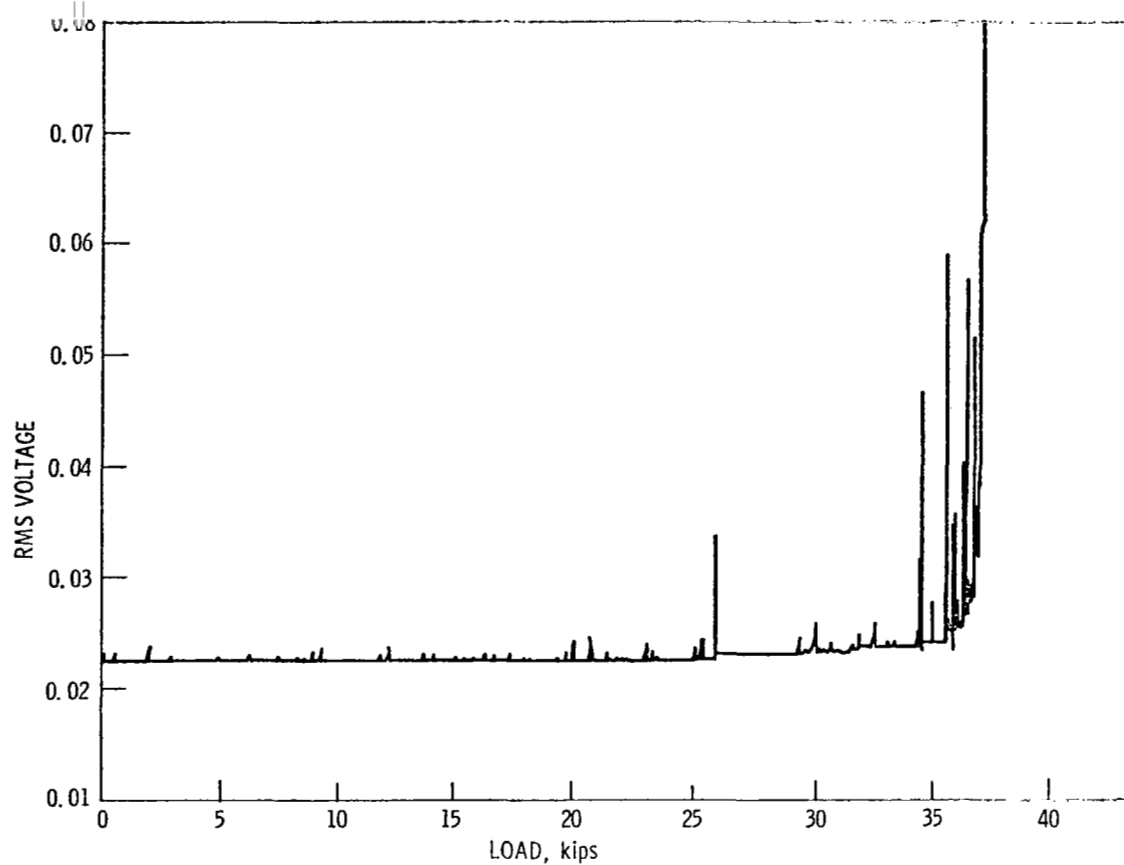
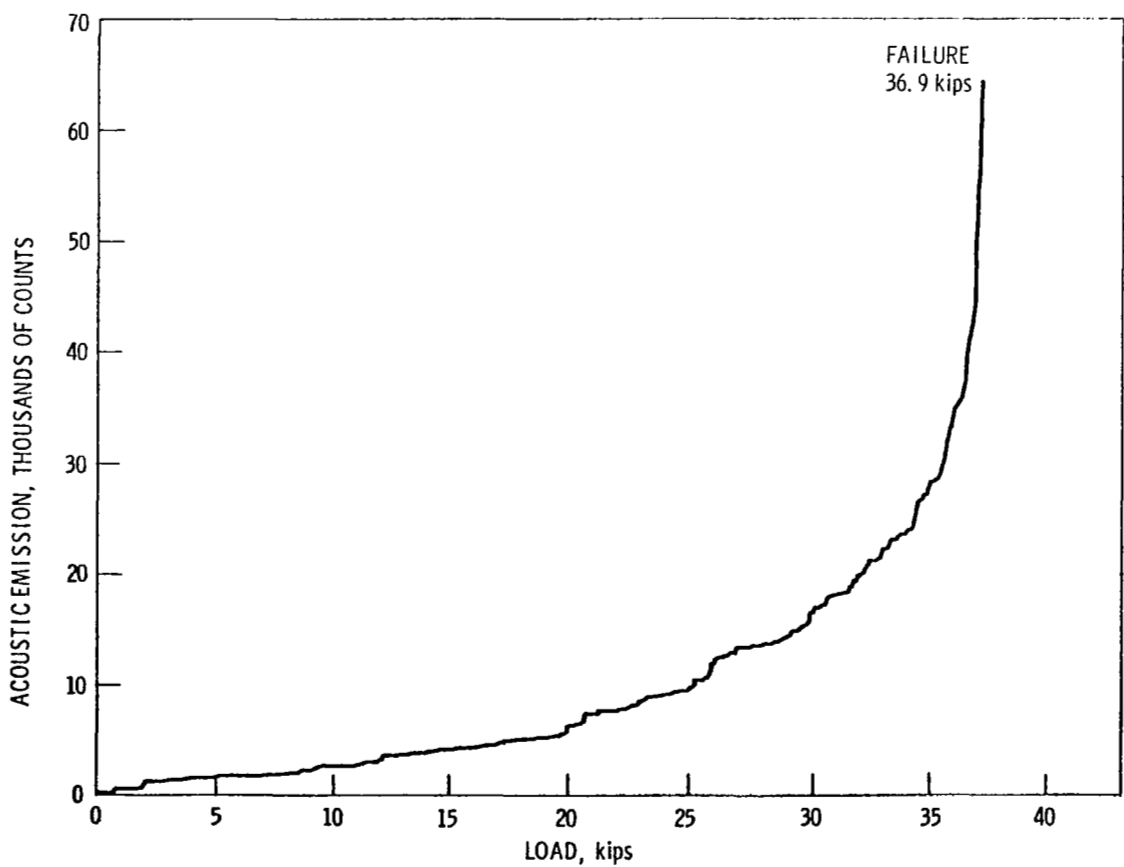
Figure 26. Precursor of Plane Strain Fracture of 2014-T6 PTC-Tension Specimen No. 2 Tested at Room Temperature.

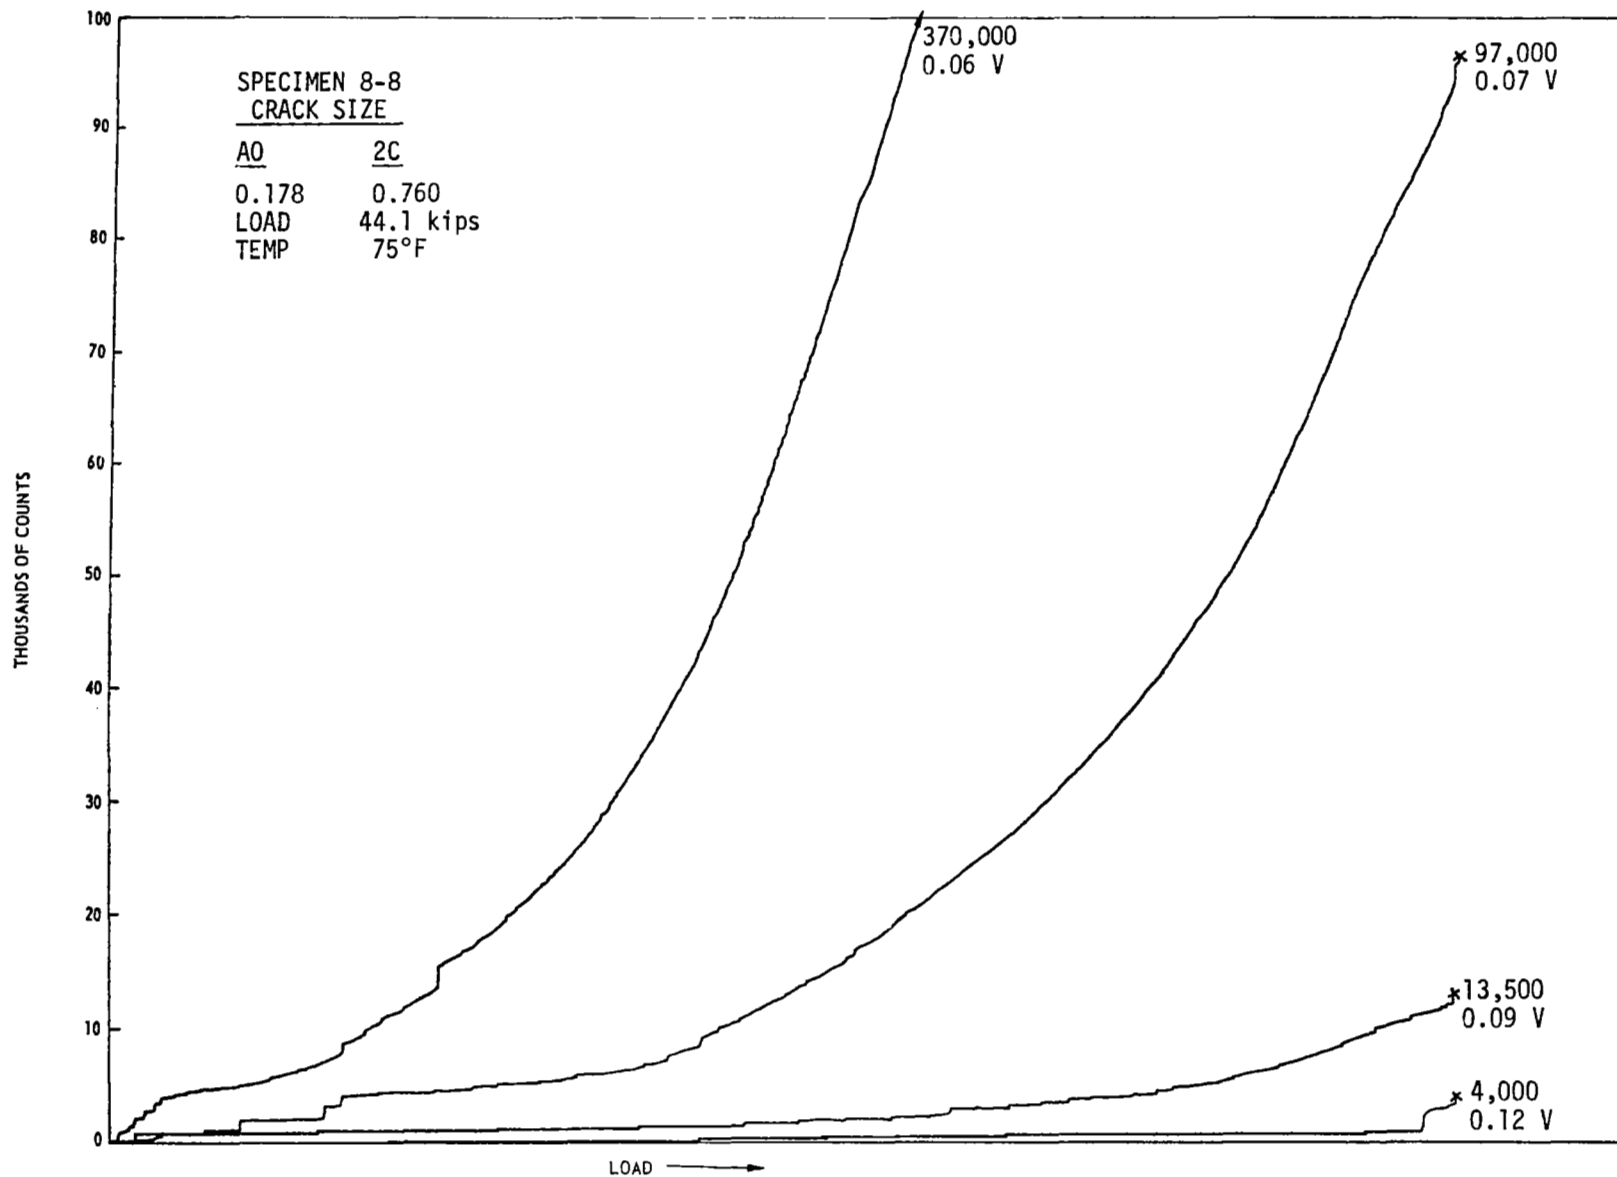
Figure 27. Effect of Trigger Level on SWE Precursor in 2014-T6 Tested at 75°F.

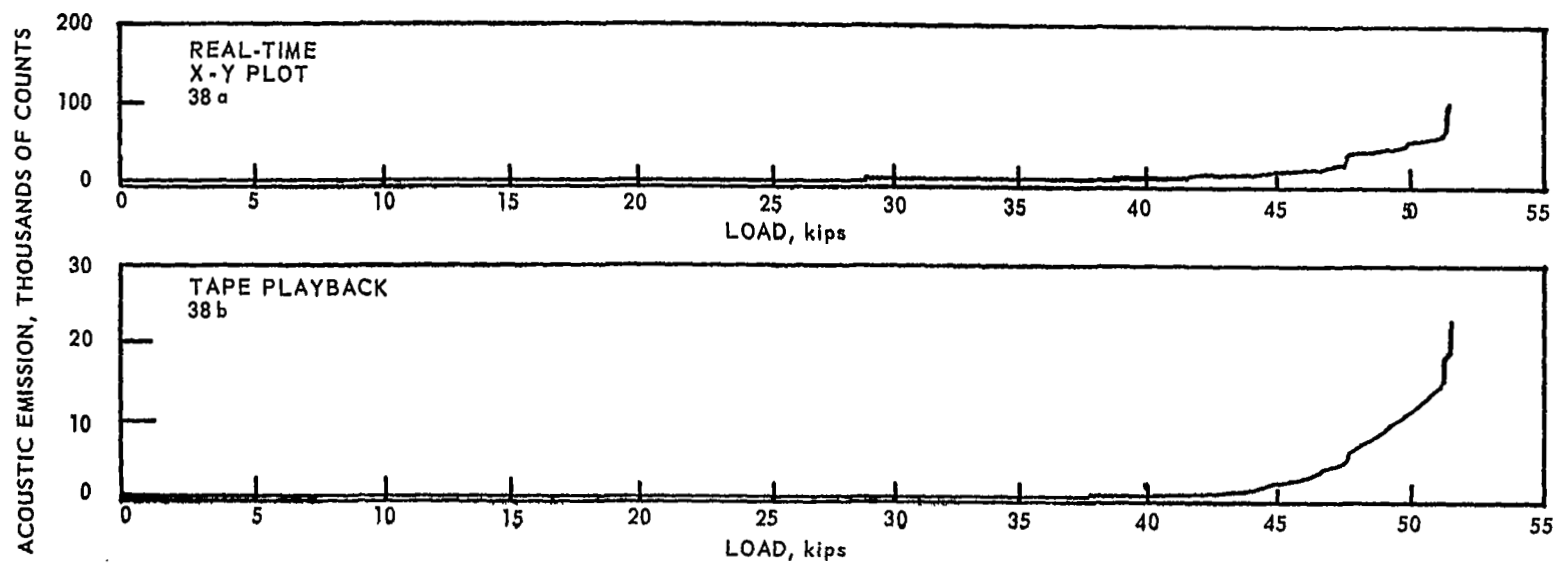
Figure 38. Effect of Tape Playback on Cumulative Count in 2219-T87
Specimen No. 32 Tested at -320°F .
